# VIBECHECK PRO

## **Vibration Analysis Survey Report**

**Fourways Crushing Plant**

**VCP003/01/0026**

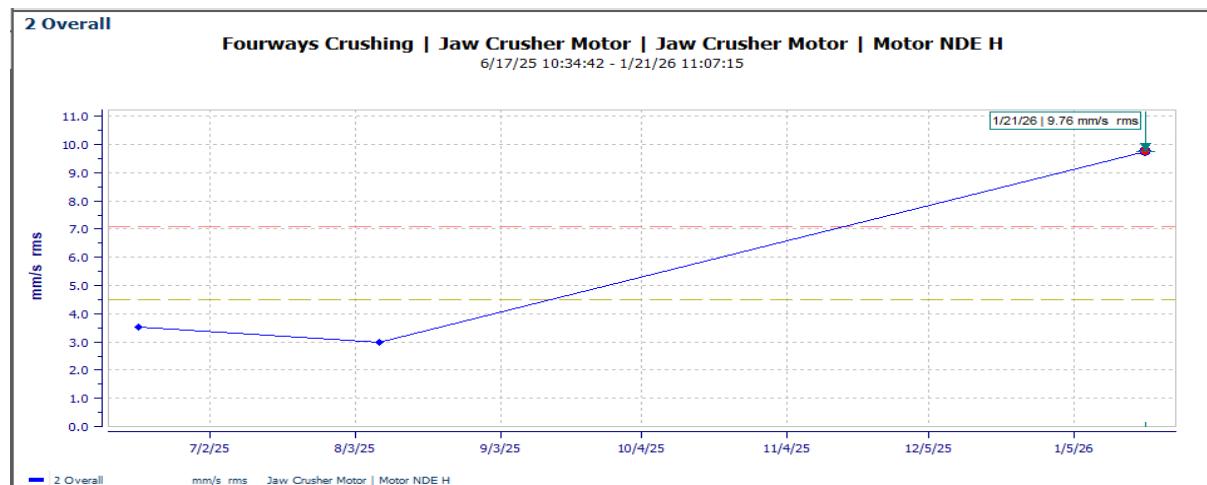
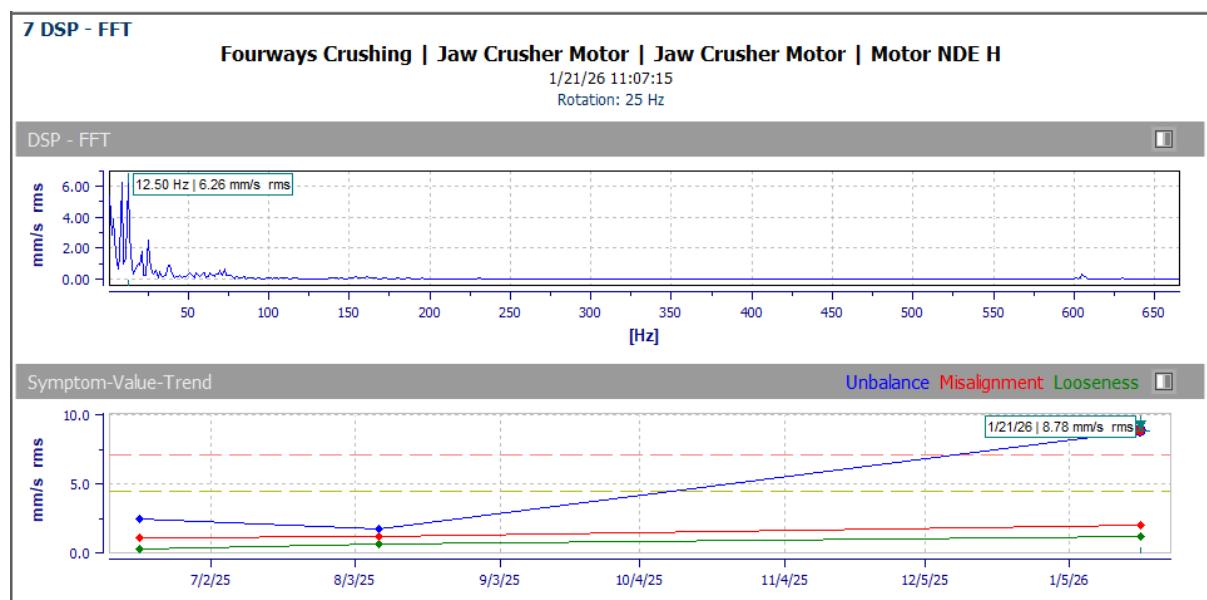
### Motor NDE Horizontal

**Fault:** Structural looseness, Unbalance

**Findings:** Overall vibration on the motor NDE horizontal is trending upwards from 3.0 to **9.8** mm/s RMS. Spectra shows a dominant 1x vibration, which is characteristic to structural looseness. Motor DE bearing exhibits a strong 1x vibration suspected from the crusher running speed, this characteristic to unbalance.

**Recommendations:** Inspect and address any loose motor hold down bolts or weakened structures supporting the motor and the crusher. Inspect motor cooling fan and crusher pulleys for stuck dust accumulation and clean to remove dust accumulation.

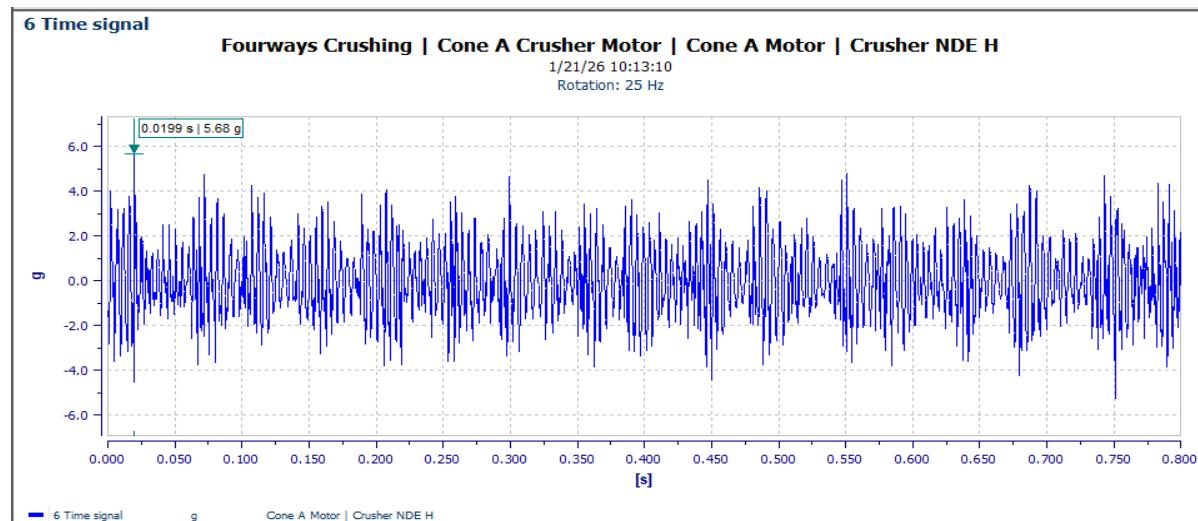
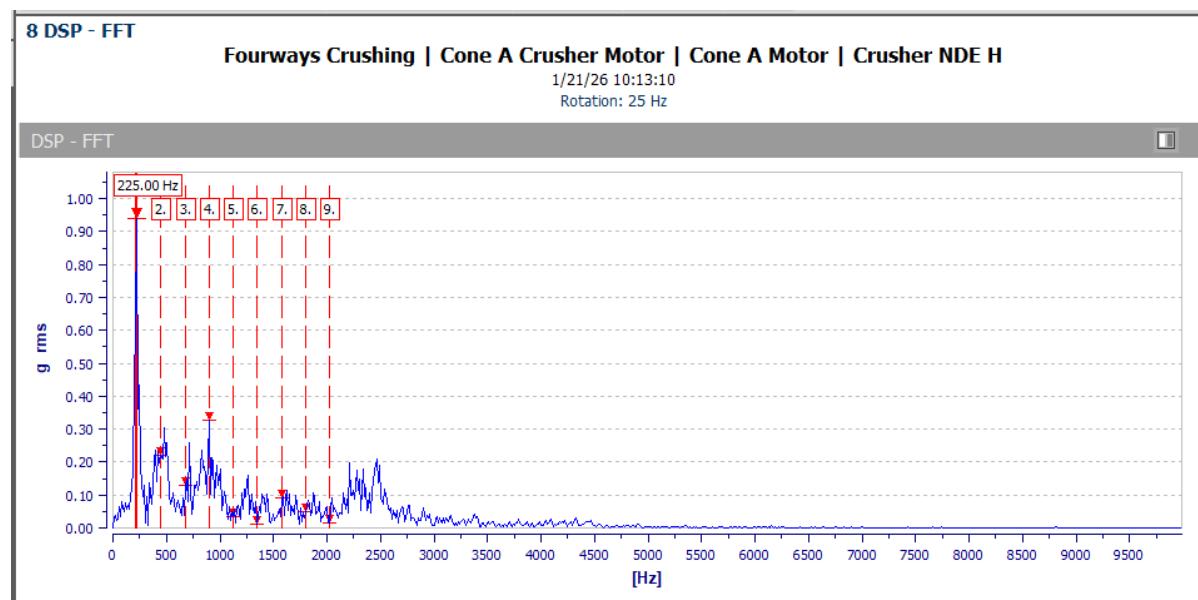
### Crusher NDE Horizontal

**Fault:** Bearing fault

**Findings:** Time waveform shows distinct impacting of up to **5.7 G's**, which can be associated with bearing fault. Suspected bearing defect at 225Hz.

**Recommendations:** Ensure the crusher bearings are adequately lubricated. Continue to monitor and trend.

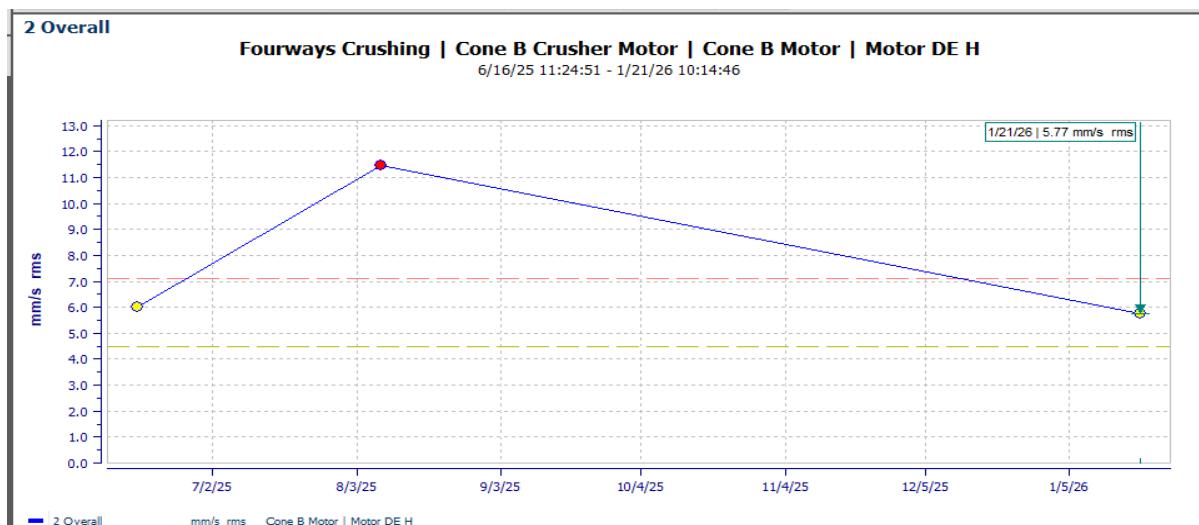
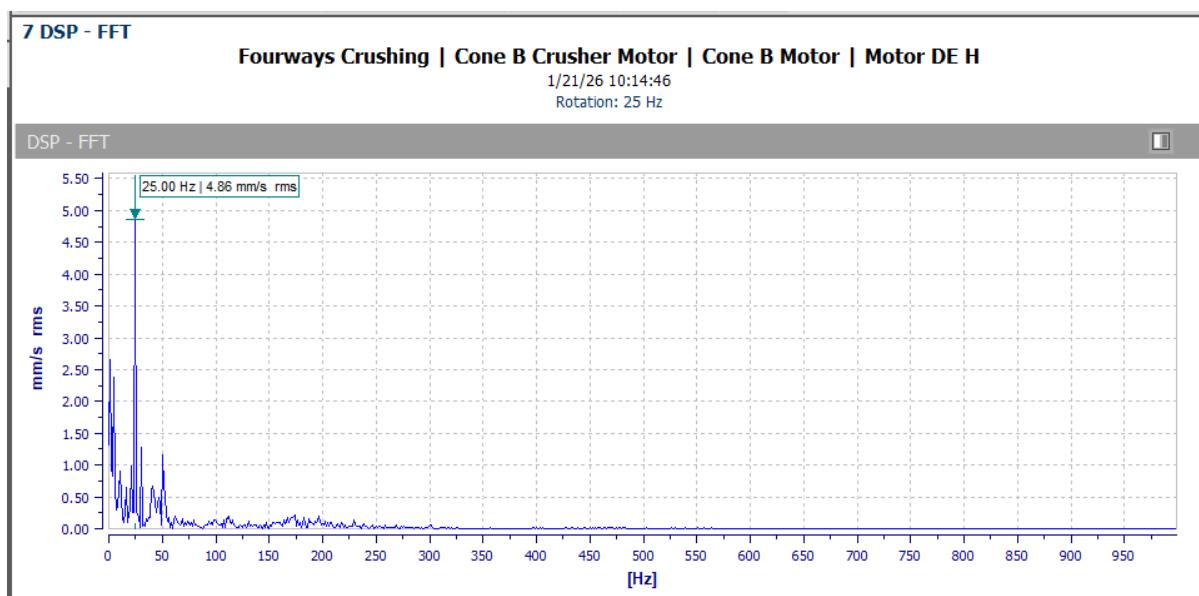
### Motor DE Horizontal

**Fault:** Structural looseness

**Findings:** Overall vibration on the motor DE Horizontal is trending upwards from **11.5** to **5.8** mm/s RMS. Spectra shows 1x vibration which is characteristic to structural looseness.

**Recommendations:** Inspect and address any loose motor hold down bolts or weakened structures supporting the motor. The recommended practice is to isolate the motor and crusher structural framework.

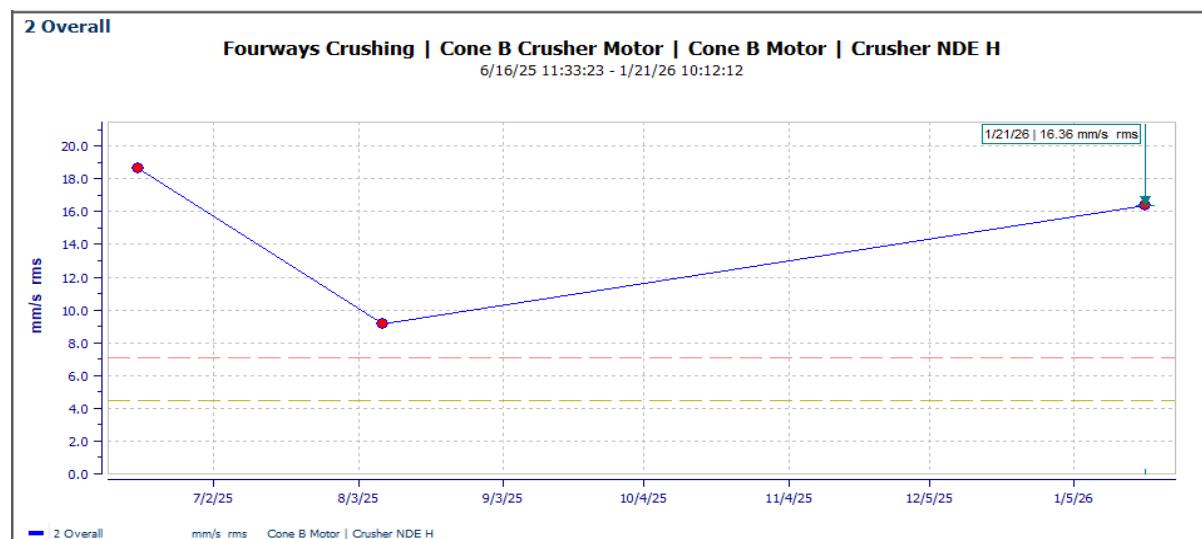
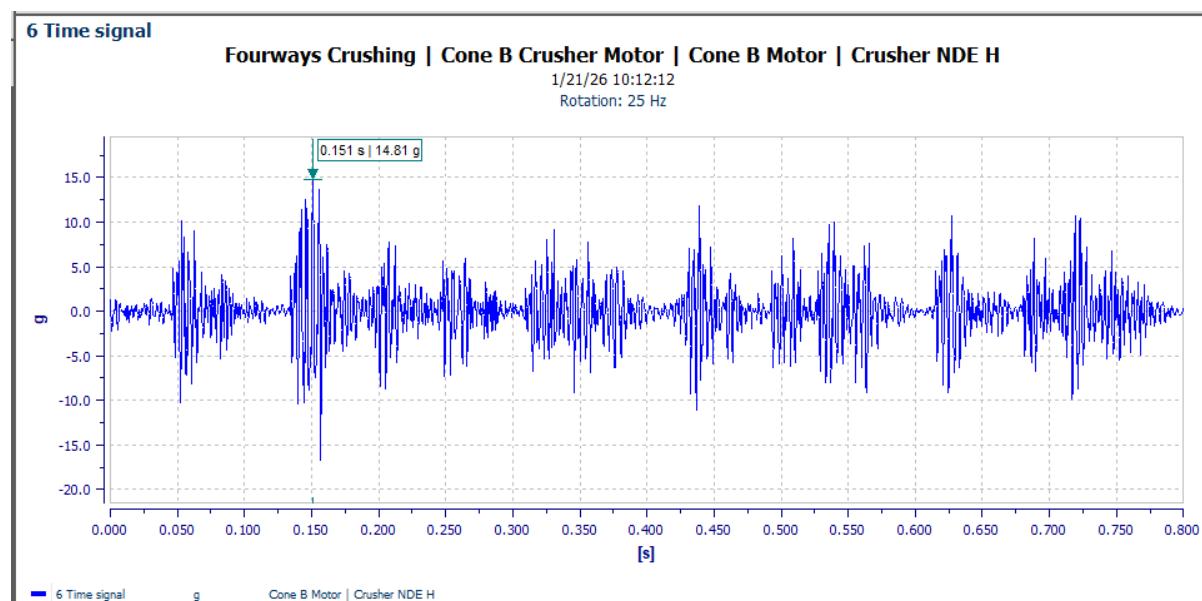
### Crusher NDE Horizontal

**Fault:** Bearing fault, Lubrication fault

**Findings:** Overall vibration on the crusher NDE Horizontal is trending upwards from **9.2** to **16.4** mm/s RMS. Time waveform plot shows distinct impacting of up to **14.8 G's**, which can be associated with bearing fault. Random broadband noise floors dominate the spectrum which is associated with lubrication fault.

**Recommendations:** Ensure the crusher bearings are adequately lubricated. Continue to monitor and trend.

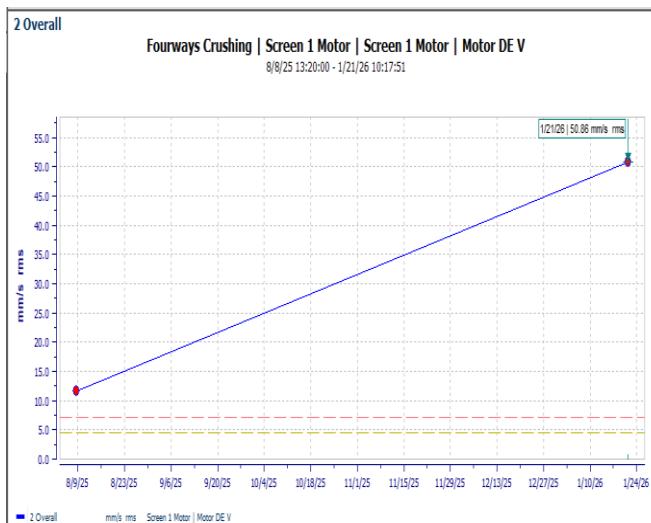
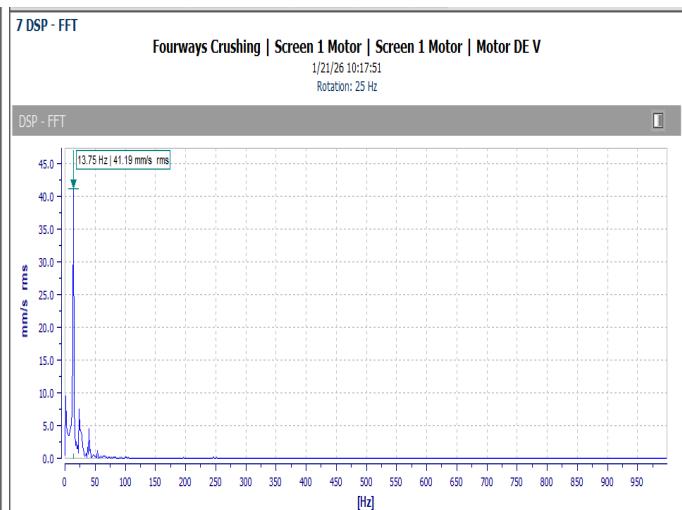
### Motor DE Vertical

**Fault:** Structural looseness, Belt Misalignment

**Findings:** Overall vibration on the motor DE vertical is trending upwards at **50.9 mm/s RMS**.

Spectra shows a strong 1x vibration which is characteristic to structural looseness. Axial vibration is upwards from **13.3** to **21.8 mm/s RMS**, this is an indication of belt misalignment

**Recommendations:** Address any loose motor hold down bolts, weakened structures to improve the structural rigidity. Inspect belts for wear and damage and replace as per condition, schedule for belt alignment. Visible cracked framework supporting the motor.

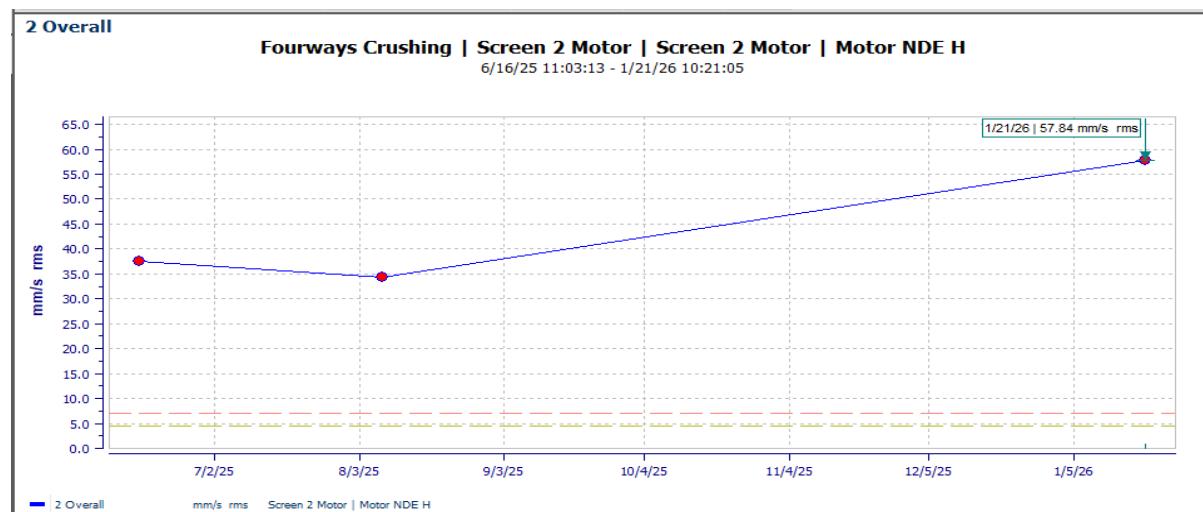
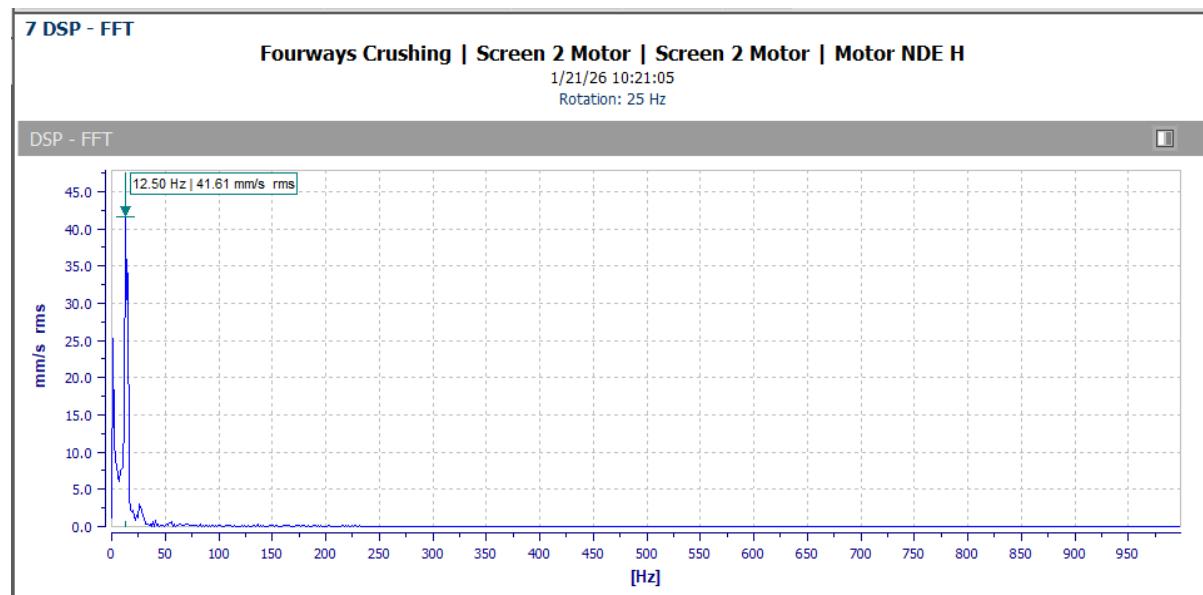
### Motor NDE Horizontal

**Fault:** Structural looseness, Loose belts

**Findings:** Overall vibration on the motor NDE Horizontal is trending at **57.8** mm/s RMS. Spectra shows a strong 1x vibration which is characteristic to structural looseness. Drive belts were flapping indication unequal belt tensioning.

**Recommendations:** Inspect and address any loose motor hold down bolts, weakened structures to improve the structural rigidity. Replace the belts and ensure all belts are equally tensioned. Inspect motor cooling fan for dust accumulation and clean as per condition of the fan. Visible cracked framework supporting the motor

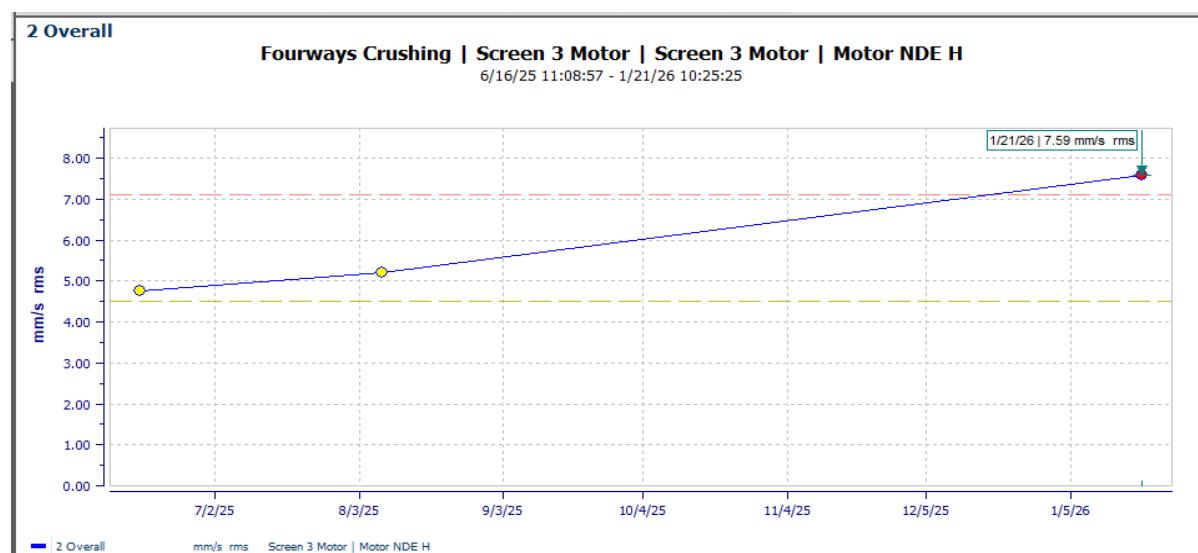
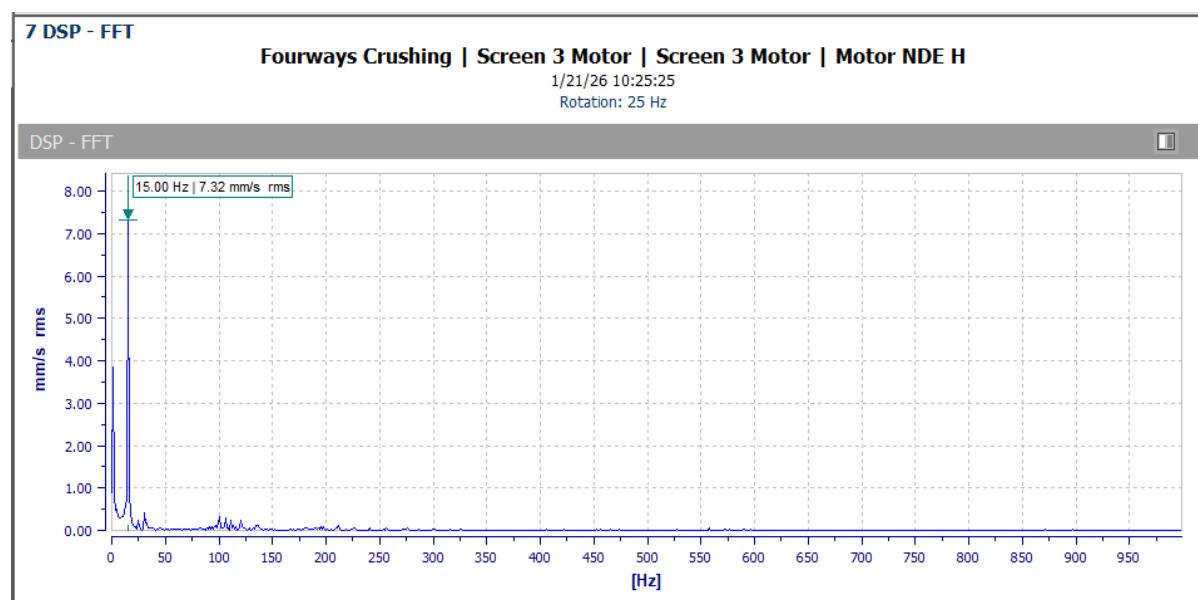
### Motor NDE Horizontal

**Fault:** Structural looseness

**Findings:** Overall vibration on the motor NDE Horizontal is trending at **7.6 mm/s RMS**. Spectra shows a strong 1x vibration which is characteristic to structural looseness.

**Recommendations:** Inspect and address any loose motor hold down bolts, weakened structures to improve the structural rigidity. Inspect motor cooling fan for dust accumulation and clean as per condition of the fan.
